A JOINT EFFORT TO REPAIR A BUSY CALIFORNIA HIGHWAY INTERCHANGE

REPAIRING UNRAVELING JOINTS

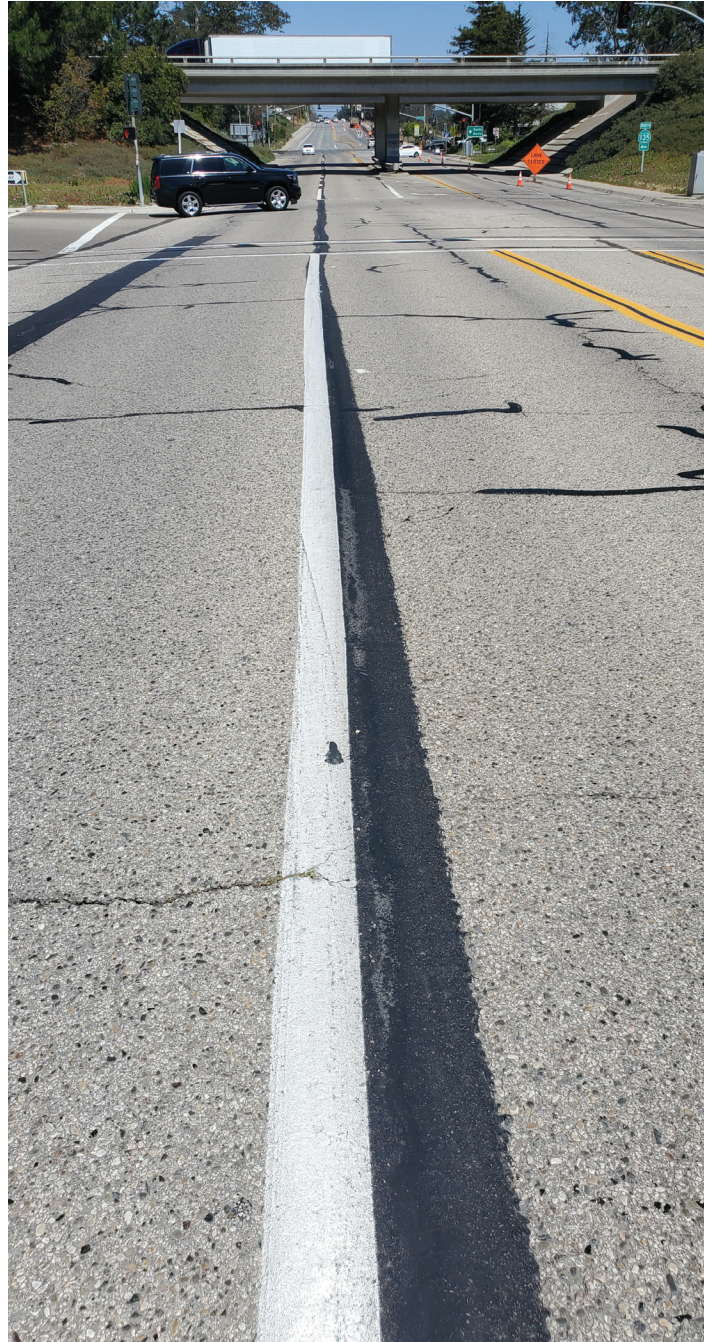
The crew applied 100 yards of the Mastic One material at a time with the drag box, saving the county countless hours.

Using the Crafcro Patcher II melter, the crew applied 100 yards of the Mastic One material at a time with the drag box. By milling out 100 yards of the material at a time, the crew

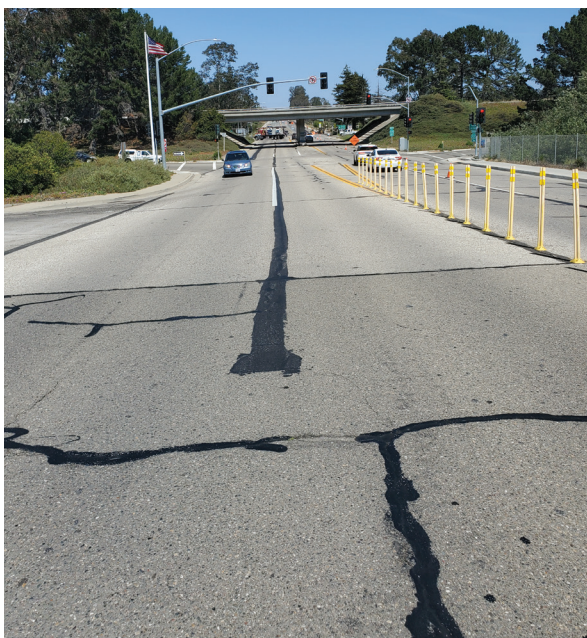
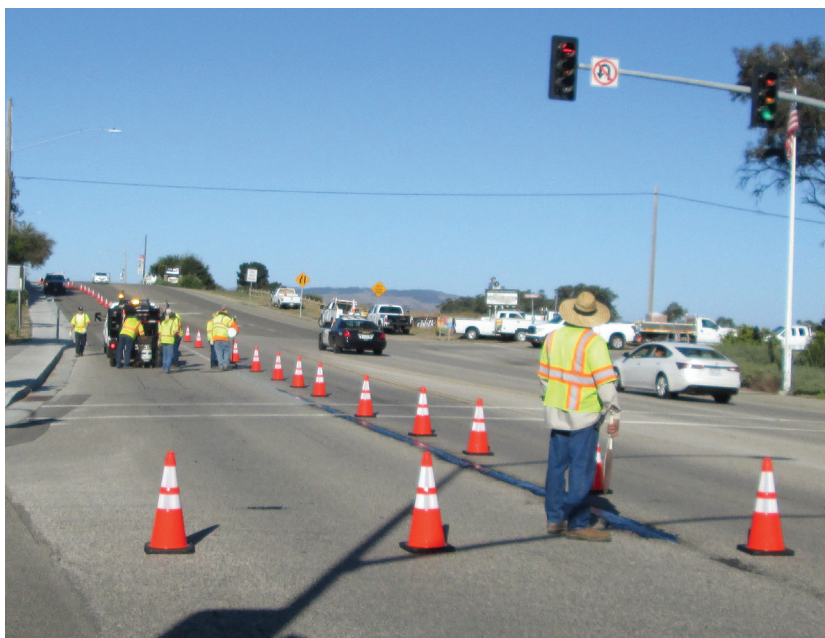
Mastic One cools quickly after installation and is ready for traffic when it has solidified sufficiently to support loads.

Because Mastic One cools quickly after installation and is ready for traffic when it has solidified sufficiently to support loads, the crew was able to complete the repairs quickly and minimize disruption to traffic flow. “Mastic One is traffic ready in less than an hour from application,” O’Brien says. “With a lot of heavy trucks using that intersection, the time we saved was really important.”
